Report No. K-P-6257

UF₆ RELEASE AT K-402-9

MARCH 11, 1976

This report describes a UF_6 release which occurred in K-402-9 on March 11, 1976. Events preceding and following the release, health physics and environmental evaluations, and recommendations to prevent future releases are presented.

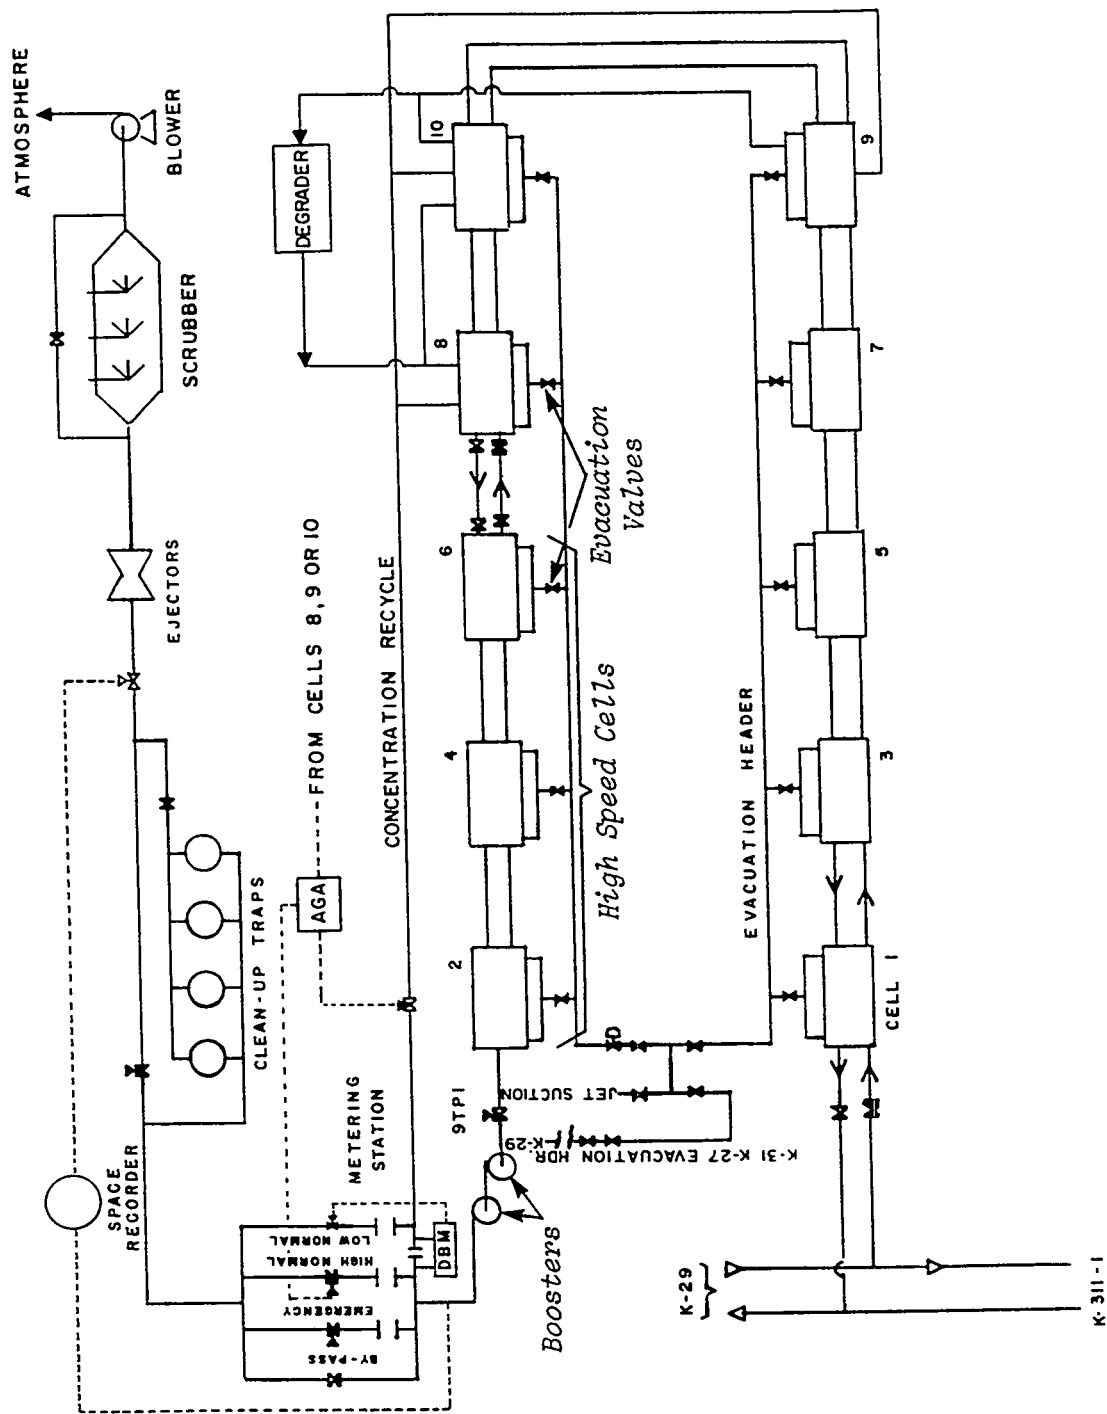
Figure 1

Inspection of the cell 6 evacuation valve instrumentation revealed that the wiring for the *open* and *close* positions on the K-29 ACR graphic panel were reversed. The cell pressure charts further revealed that this valve was inadvertently opened before 2100 on March 10.

LINE DIAGRAM OF K-402-9 PURGE CASCADE

The cell 8 evacuation valve was opened at 2100 on March 10 to bleed light gases to the K-29 A booster. Since cell 6 evacuation valve was already open, this route also allowed these light gases containing some UF_6 to enter cell 6 and continue through the top boosters, the alumina traps (where a major portion was adsorbed), and the jets to the atmosphere. This *bleed* continued from 2100 on March 10 to about 0730 on March 11, 1976.

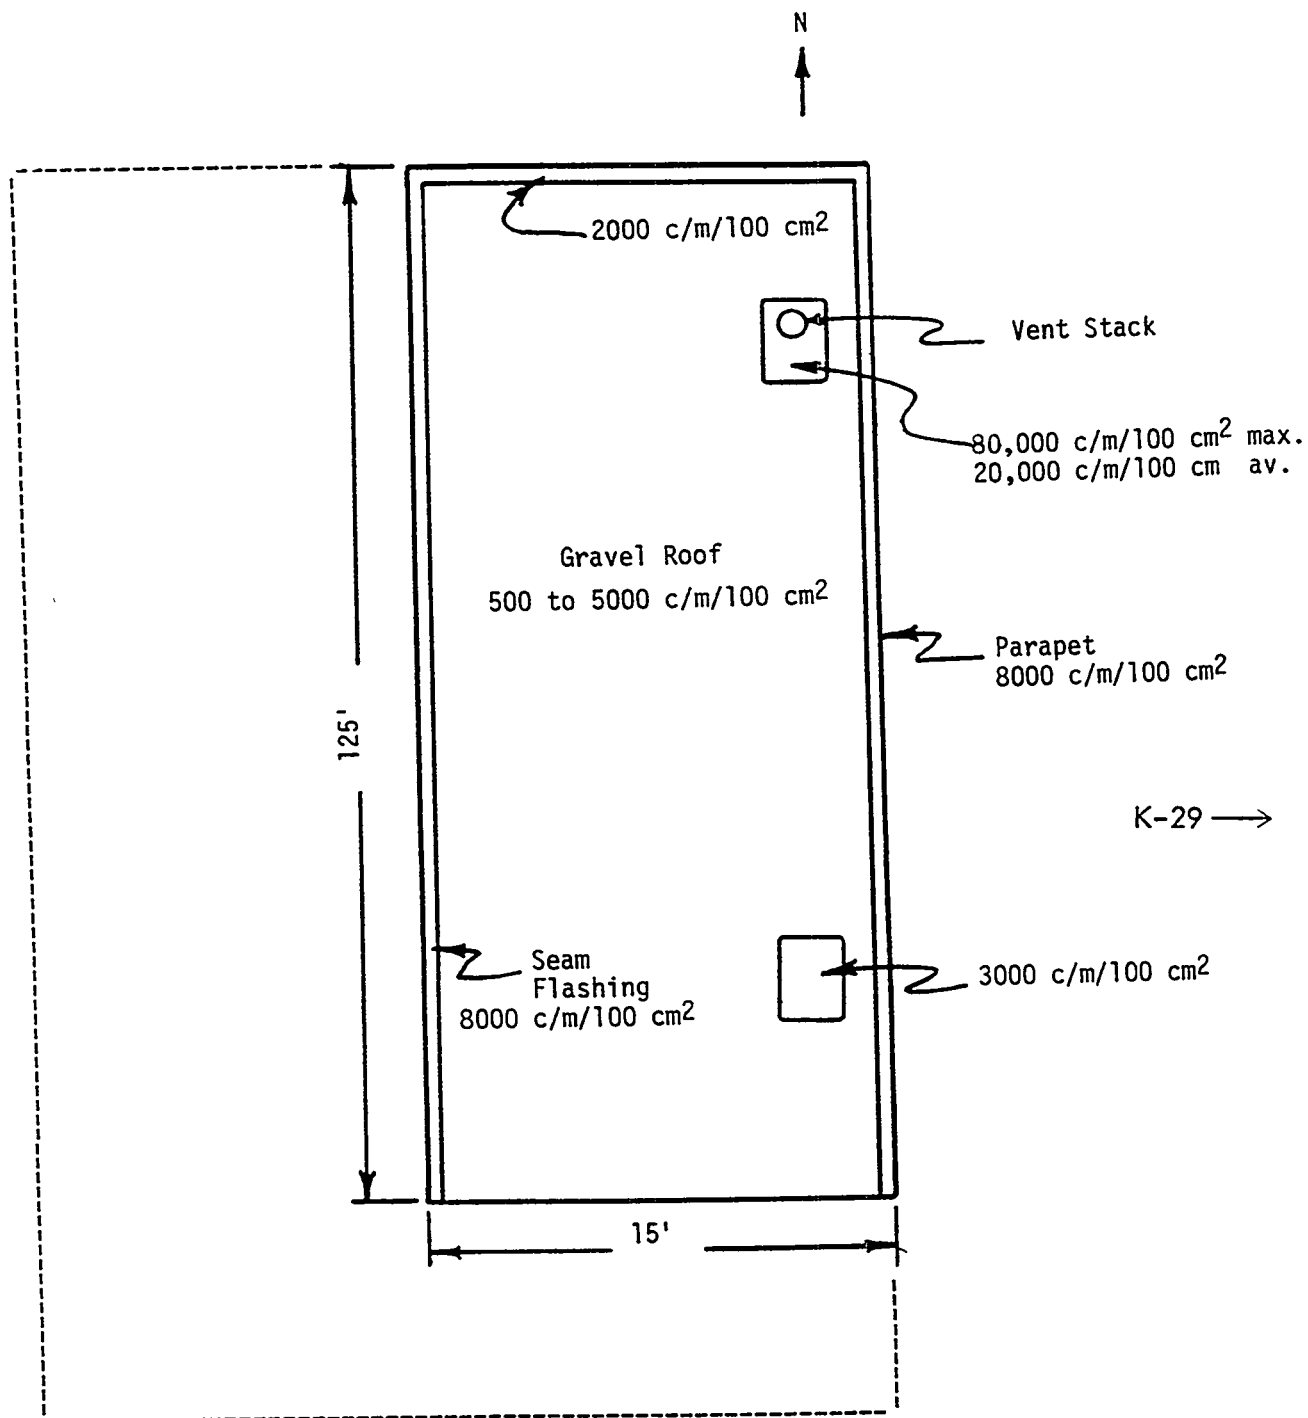
Figure 2
HEALTH PHYSICS SURVEY NORTHEAST CORNER OF K-402-9 ROOF

Radiation survey data indicate that the material was dispersed primarily over the roof area to the South of the vent. The data are consistent with the direction of discharge from the vent stack.

Approximate positions of maximum readings on the parapet, seam flashings, and hatch covers are indicated in Figure 2. A survey of the K-402-9 roof conducted only a few days prior to the release to determine health physics requirements for a reroofing job revealed no apparent uranium contamination. On the basis of the survey data shown in Figure 2, the amount of uranium deposited on the roof area did not exceed 150 grams, which was considered to represent a large fraction of the total material released.
